Technical Guide

Guide to Assessment and Repair of Flood Damaged Timber and Timber Framed Houses

(Revised March 2025)

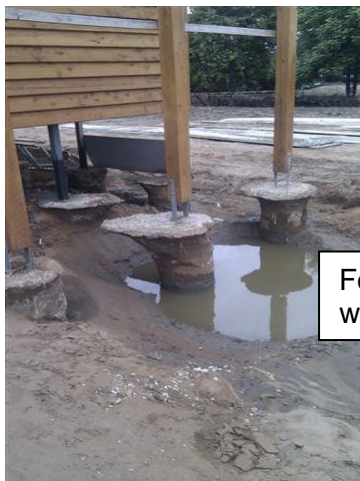
Footings scoured out by fast flowing water

Failure to address or correct these types of faults could severely affect the future structural performance of the building.

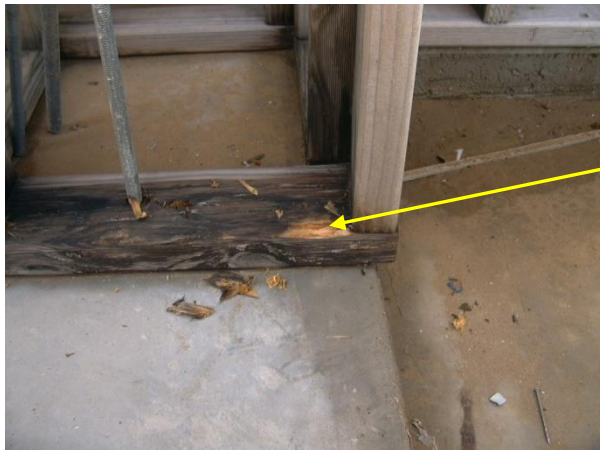
Although heavily discoloured with surface mould and blue stain, the pine timber is still sound as shown by scraping back the surface layer

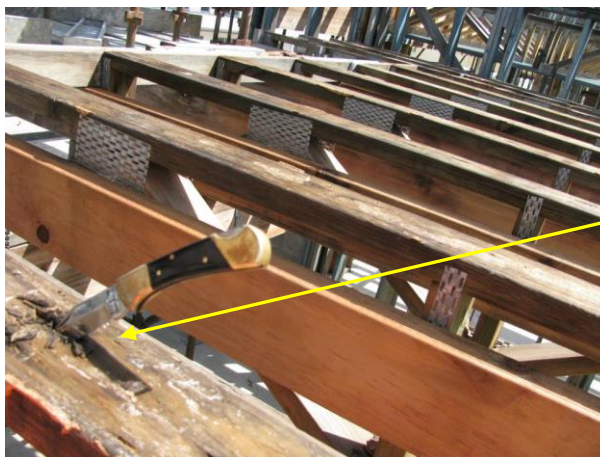
Decayed timber is soft and spongy and can easily be penetrated with a knife or screwdriver

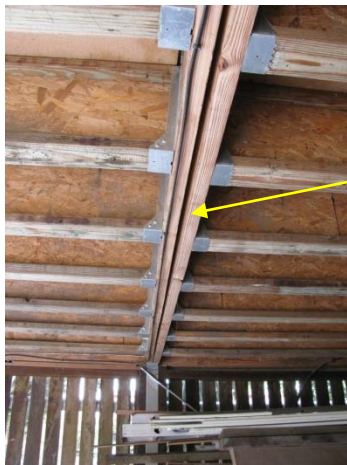
Expansion of the hardwood T&G floor above has caused the separation of double bearers.

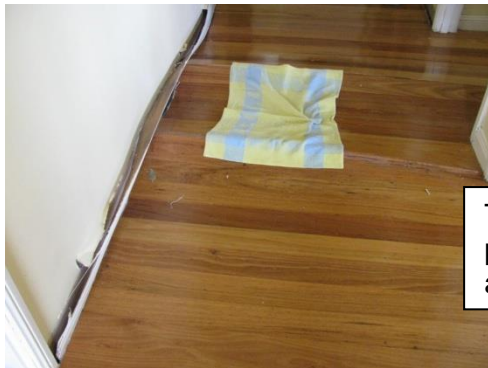
This inundated T&G floor over particleboard tented about 1 week after the water receded.

Allow the flooring a minimum of 4 months to dry out before re-assessing. Gaps between boards are highly likely to occur as the floor dries out, however the structural adequacy of the flooring is not likely to have been compromised and floors may be lived on in the meantime.

Following re-assessment, consideration can then be given to rectification in accordance with industry recommendations which may include the following options:-

- Re-sanding and polishing
- Overlaying with a new thinner overlay timber floor
- Replacing the floor with a new timber floor
- Installation of alternative floor coverings
