Technical Guide

Guide to Assessment and Repair of Flood Damaged Timber and Timber Framed Houses

(Revised March 2025)

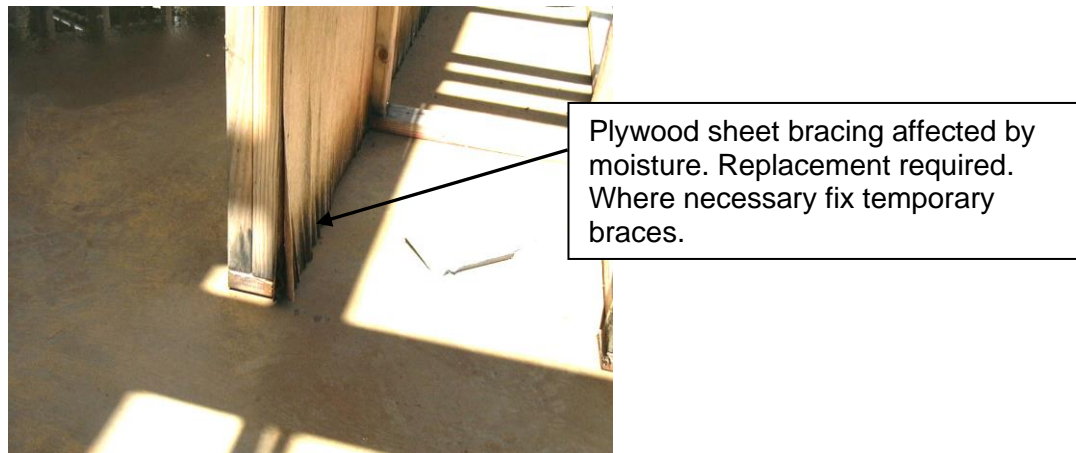
Irrespective of the need to access frames for cleaning etc, **most lining products** that have been inundated (T&G VJ, plasterboard, plywood, hardboard ('Masonite'), medium density fibreboard, etc) will need to be replaced.

Lining should be removed to at least 300mm above the highest level of inundation (or further if required for adequate re-instatement of the lining i.e. half wall height or full wall height). Inundated bulk (batts) wall or ceiling insulation will need to be removed and replaced during cleaning and repairs.

In houses built after about the mid 1970's, **wall bracing** using wall lining materials (plasterboard, plywood, hardboard and fibre cement etc) as the brace may have been used. Where wall linings are stripped, temporary diagonal timber braces (70x35 pine) at 30° to 60° should be nailed to the top plate, bottom plate and studs to each wall to maintain the houses bracing strength prior to re-instatement of permanent bracing and wall lining.

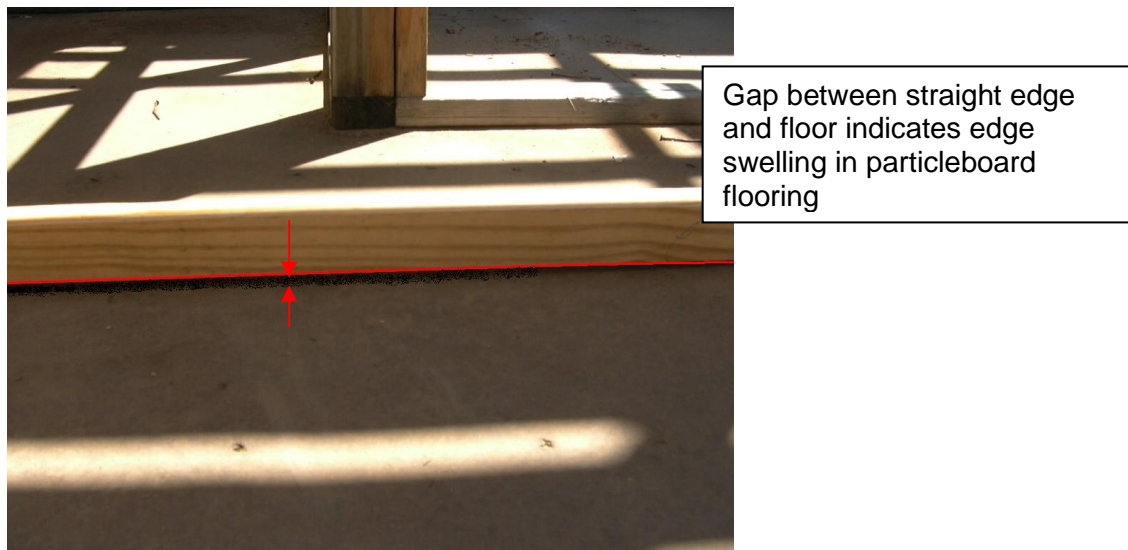
Particleboard flooring is more susceptible to moisture induced swelling than timber or plywood, particularly at sheet edges and depending upon the type of particleboard (some boards are manufactured using moisture resistant glues), may have suffered loss of structural integrity. There will be only minor loss of swelling when the particleboard dries out.

After cleaning, assess the extent of swelling and or lifting of sheets off the joists. Check to see if there is still clearance between the edges of sheets and the bottom plates of walls (usually under the skirting board). If necessary relieve the pressure on bottom wall plates by provision of relief cuts in the sheet edges as close to bottom plates as possible. Eliminate any trip hazards that may have arisen due to edge swelling, lifting sheets or nails and screws etc.

Allow the particleboard flooring a minimum of 4 months to dry out before re-assessing and any rectification that may be required. As a guide only, it is suggested that if sheet edges have swollen more than 2mm (i.e. would need to be sanded back by 2mm or more to get a flat floor) then the structural adequacy of the flooring has been compromised and needs rectification by either replacement or installation of a new structural floor over the existing particleboard.
